Failure analysis and repair of the telescopic beam belonging to the spreader of a reach stacker for port operations

Abstract— Reach stackers land equipment operating in ports of the Colombian Caribbean, are subject to several critical working conditions such as; corrosive environment, excess working hours, overload and lack of predictive maintenance. This work focuses on the failure analysis and the elaboration of the welding repair procedure of the telescopic beam belonging to the spreader of a Reach stacker that operates in a Colombian Caribbean seaport. Initially the fault zone was characterized; by mean a metallographic analysis and a hardness profile to identify the type of structural steel of which the beam is composed, obtaining an A514 grade C of 110KSI of tensile strength and 34HRC of hardness. The equipment manufacturer was verified and the established by the laboratory tests was corroborated. After identifying the material, the fracture area was analyzed where patterns of beach markings were found, typical of a fatigue failure which extended from the circumference of separating pins to the surface of the beam. The inclusion of the separators in the initial design genera

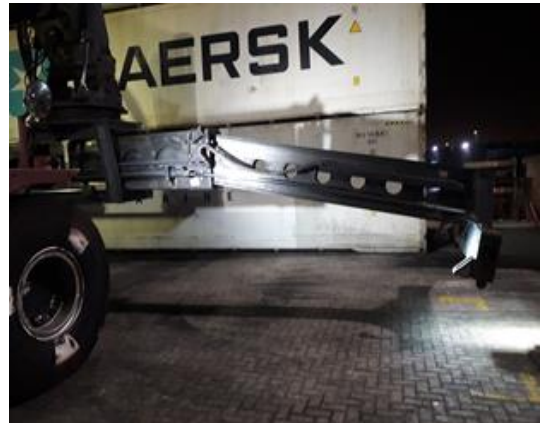
Taking the refrigerated container off the floor when lifting it, the spreader extension was split on the right side (Fig 1).

Fig 1. Fractured Telescopic Beam.

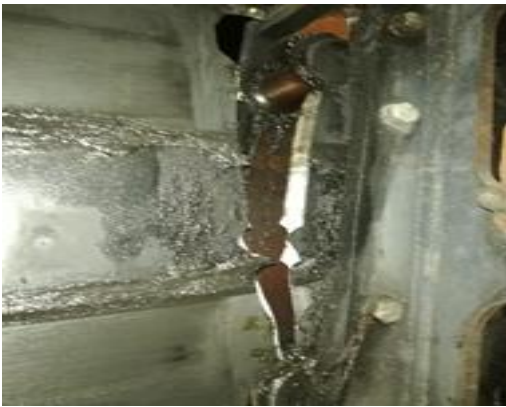
- The fracture occurs in the spreader telescopic system beam when the spreader is in the 40-foot position (Fig 2).
- The fracture begins within the tunnel of the telescopic system (2 inches measured from the outer edge).
- It is evident that the fracture area is not visible when the spreader is open at 40 feet which prevents seeing any defect in the material.
- Cylindrical elements welded along the fracture
- The fissure is presented at 2 inches measured from the edge of the frame (Fig 3).

Fig 2. Fractured area.

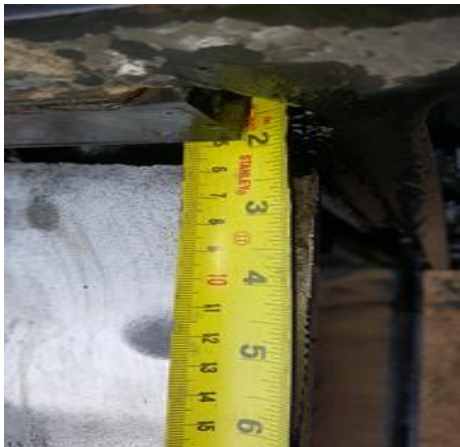
Fig 3. Fissure Length since pin separator to frame.

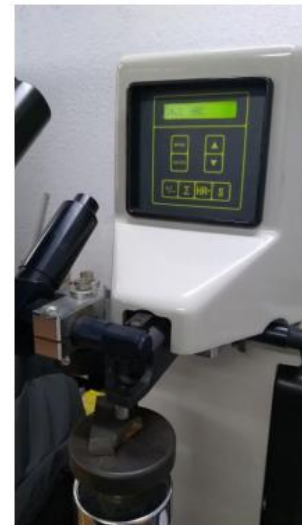
After calibrating the Bench hardness tester, the hardness profile was measured on the upper faces and bottom of the sample as seen in Fig. 4. Three points were measured on each face longitudinal and then the average was taken as established by ASTM E10.

Fig 4. Hardness measure on bench.

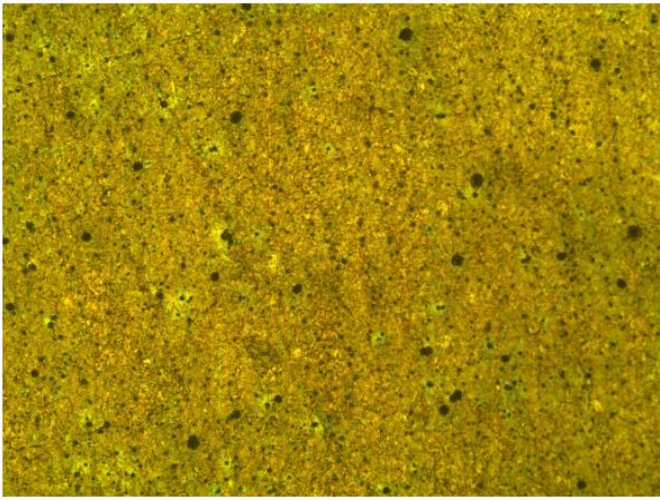
Fig 5. Metallographic taken at 200X.

Photomicrograph Fig. 5 shows a typical microstructure of low carbon steel, in where perlite (dark areas) precipitated on the grain edges of a matrix is observed ferritic (clear areas). Metallographic analysis corroborates the hardness measurement, relating the sample to A514 steel, which has a carbon content of 0.26%. Table II shows the composition and the main mechanical properties of this do according to a provider.

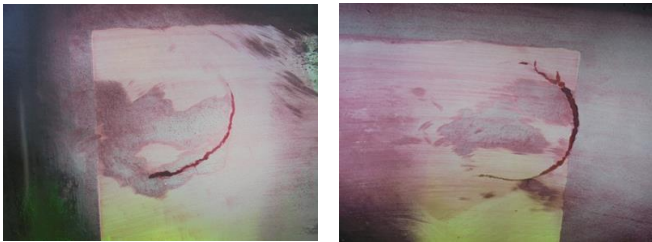
After disassembling the billed arm, the left arm was dismantled and penetrating ink tests were performed. On both sides of the beam cracks are evident around the spacer pins (Fig 6).

Fig 6. Cracks on pin separator revealed by penetrating liquids

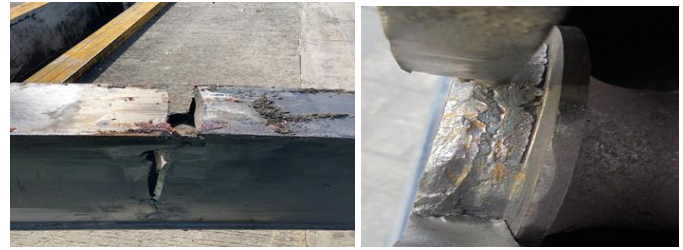
- The type of material used in the construction of Spreader is a T-1 alloy (registered trademark of the ArcelorMittal steel company) equivalent to A514 steel
- Mechanical properties of A514 steel; creep limit at least 100 ksi (689 MPa) for thicknesses up to 2.5 in (63.5 mm)
- Breaking tension at least 110 ksi (758 MPa), with a specific range of 110-130 ksi (758 - 898 MPa)
- Discontinuities, porosity, lack of fusion and cracks in

the weld are evident between the cylindrical separator and the base material sheet, like shows Fig. 7.

Fig 7. Welding between cylindrical separator and sheet.

- Cause "Failure due to defective material". Discontinuities were evidenced by lack of fusion and welding porosity between the separator pin and the beams; Evidence of the fracture around the separator pin

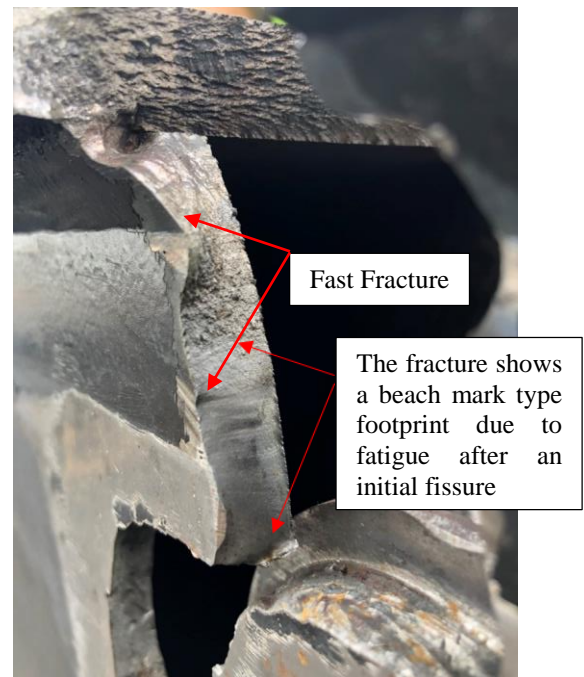
The surface of the blade fracture has beach marks and rapid fracture. Since beach marks spread away from the origin in a series of concentric arches, the site from which the crack originated can be identified by drawing an imaginary radius perpendicular to them” [11]. Therefore, it can be inferred that the fracture originated at the limit between the sheet and the cylindrical separator.

The failure could have been caused by fatigue, the most likely root cause being an inappropriate choice of the type of welded joint used, that is, a poor design. This design is not recommended for dynamic structures.

Sudden fatigue fracture failure is evidenced being nucleated in welding imperfections between the separator pin and the base material sheet. These fatigue cracks that originated in welding could not have been detected during routine inspections since these cylindrical separators are not visible as they are within the central frame of the spreader. Therefore, it should be noted that there is no deficiency in the inspection work (Fig 8).

Fig 8. Fracture surface of the base material sheet, fractography analysis.

Welding procedure was elaborated with the code AWS D1.1 2015. Mainly parameters of welding procedure are shown in table III.

- Welding Procedure; FCAW (Flux-cored arc welding)
- Type; Semiautomatic.
- Joint Design; Total penetration, root open 1/8", bevel angle 60°, Heel 1/8".
- Welding Position; 2G, Butt joint.
- Base material; A514 grade C, thickness 12.5 mm, Butt joint.
- Electrical Characteristic; Transfer mode "Pressed", Direct current, polarity "DCEP Positive Wire",

- Filler material; Electrode E 110 T5-K4, specification.
- AWS A5.29, diameter 1.6 mm, commercial provider; Bohler/WestArco/Lincoln.
- Technique; cord swung, Multiple passed, Longitudinal, Cleaning between passes “Polisher, metallic grata.
- Protection; CO₂ gas, 100% composition, flow 20Lts/min.
- Preheating; Min Temperature 200°C, temperature between passes Min 155°C – Max 300°C.
- Post welding thermal treatment: Cover with thermal blanket until room temperature.
- Joint detail:

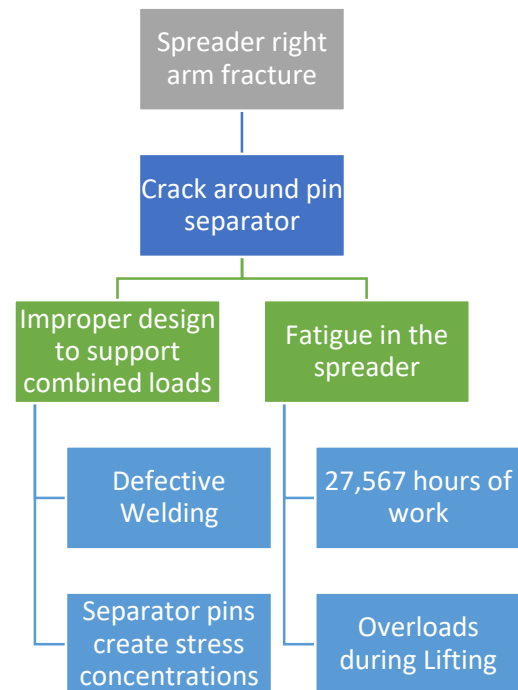
equipment is a fatigue in the structure due to a deficiency in the structural design of the Spreader, and the service bulletin "Service Bulletin Vol. 13 / Number 4 / August 6, 2013 being made known late. "This explains the problems that had arisen with these equipments in that area and where they should be inspected. Because of this, preventive actions could not be taken in a timely manner. Root cause analysis is shown in the Fig. 9.

Fig 9. Schematic block of RCA
